EXPERIMENTAL INVESTIGATION OF DEFECTS INFLUENCE ON COMPOSITES SANDWICH PANELS STRENGTH USING DIGITAL IMAGE CORRELATION AND INFRARED THERMOGRAPHY METHODS

D.S. Lobanov, V.E. Wildemann, E.M. Spaskova, A.I. Chikhachev

Perm National Research Polytechnic University, Perm, Russian Federation

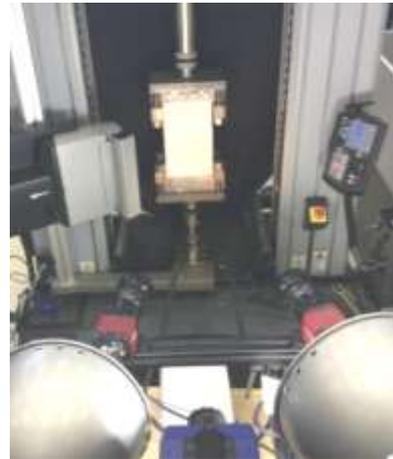
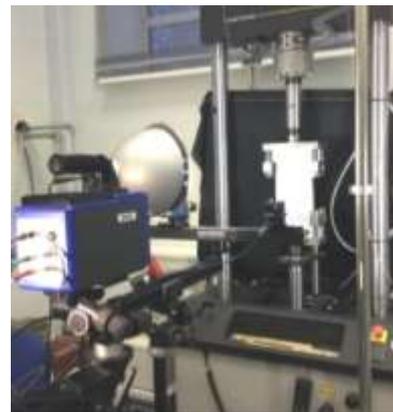
Fig. 1. ASP specimens during the testing in the electromechanic system Instron 5982 under static tension (*a*) and in the servohydraulic system Instron 8801 during cyclic testing (*b*)

The experimental studies were carried out at the Center for Experimental Mechanics of Perm National Research Polytechnic University. The research program included the mechanical tensile testing of ASP specimens sized 150×350 mm, based on the previously proposed methods [3, 4, 19, 20] under static and cyclic loadings using the contactless optical vision-based system Vic-3D and infrared imaging system FLIR to control the internal structure of the

specimen, including the repaired zone (Fig. 1). The defect is located in the central part of the ASP specimen. In order to conduct the researches, we chose the most complicated type of defects, which is most difficult to repair, i.e. the through breakdown of the structure. The defect size was chosen based on the calculation that the defect length was equal to one-half of the ASP specimen's width ($l = 70$ mm). To reduce the concentration of stresses at the edges of the defects, a radius of $R = 7,5$ mm was chosen.

The static studies were carried out using a universal electromechanic system Instron 5982. This machine is designed for quasistatic testing under tension, compression, bending with the load of up to 100 kN and the loading rate from 0,001 to 500 mm/min. A more detailed description is given in [5, 21]. The preparation of the tests consisted in setting the parameters of the test and measuring equipment using the specialized software, synchronizing the test machine with the video system and the thermal imager, preparing and installing the specimen.

The digital image correlation method (DIC) is an effective non-contact method for measuring deformations on the surface of objects under study by comparing digital images taken during loading [22]. Initially, the displacement fields are constructed, then the deformation components are calculated. With the help of the DIC method, it is possible to analyze the change of deformation fields, according to the contrast relief of the specimen, and also estimate the degree of deformation, the moment and place of its localization at the macrolevel. To analyze the displacement fields using DIC method, it is necessary to prepare the surface of the test specimens [22-24], so a contrast fine-dispersed surface is applied, then the specimen is fixed in a special test rig (Fig. 1).
